## GREAT BASIN UNIFIED AIR POLLUTION CONTROL DISTRICT

### Technical Memorandum

Subject: Preliminary Results of Plant Establishment in the Straw Bale Demonstration Dust Control Project

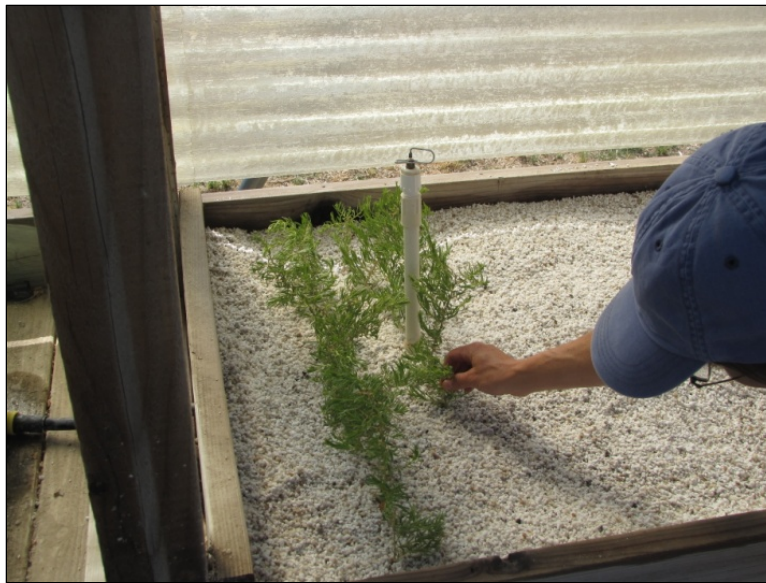
**Photo 5:** Placement of SAVE cuttings into prepared perlite bed in the cutting box.

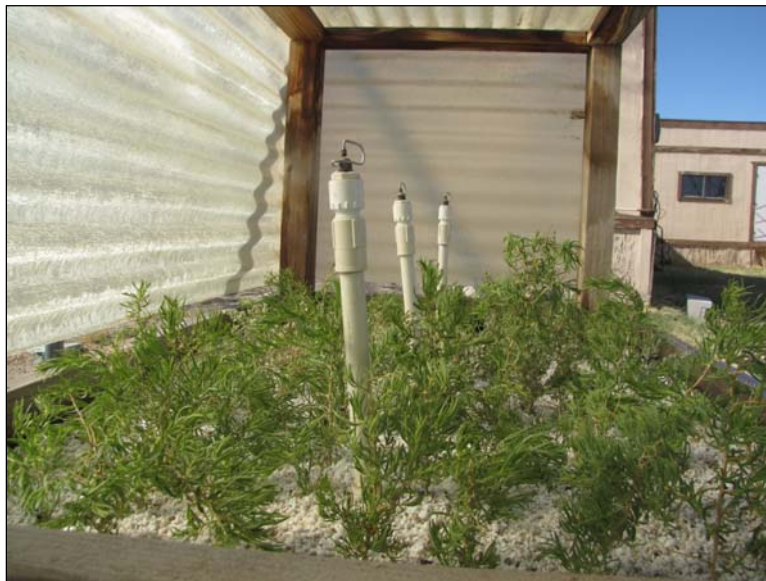
**Photo 6:** View of SAVE and ATCO cuttings in the cutting box on April 15, 2012.

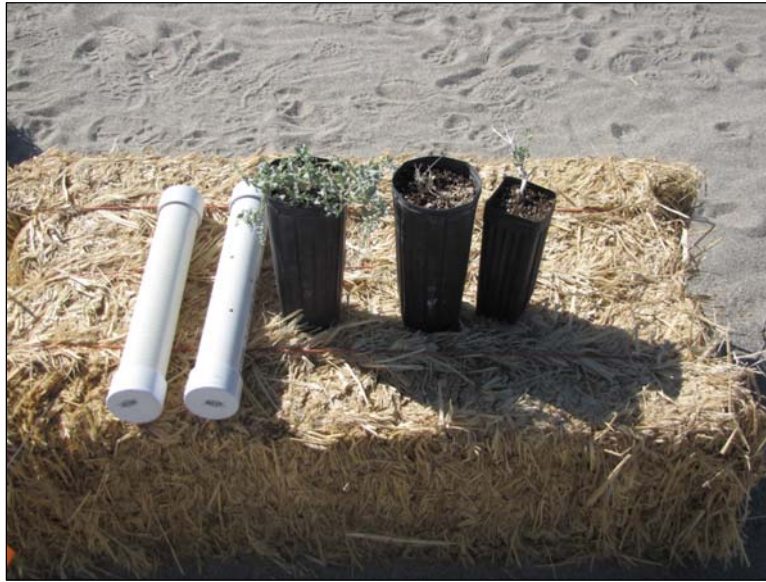
**Photo 7:** Plants and watering tubes ready for placement in the ground, May 30, 2013.

Planting of the native shrubs on the test site was conducted on May 30, 2013 in association with the first shipment of bales. The shrubs were planted in a block of 47 bales located on the southeastern portion of the test site. Three shrubs were planted along the northern side of each bale. In between the plants, two watering tubes were installed to facilitate the delivery of water directly to the root zone area (Photos 7 and 8). Figure 1 provides a map of the test site and the block of bales where the native shrubs were planted.

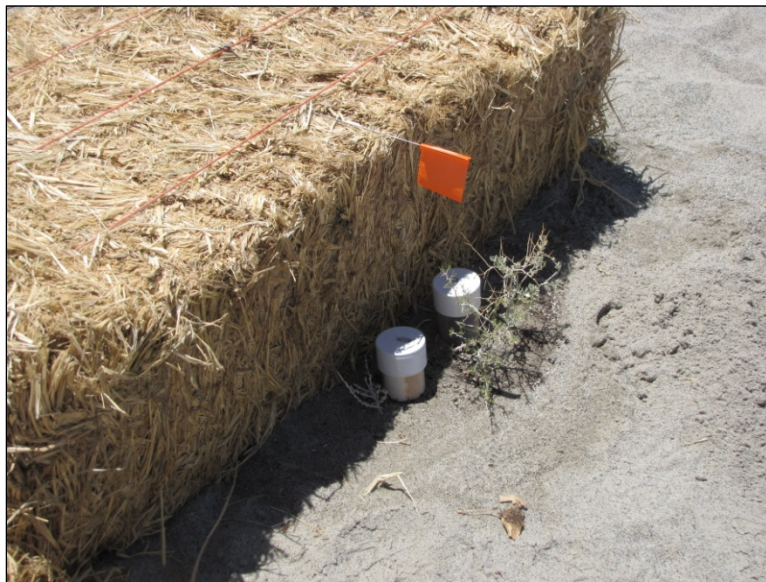
**Photo 8:** Picture of the newly planted shrubs along the edge of a straw bale, May 30, 2013.

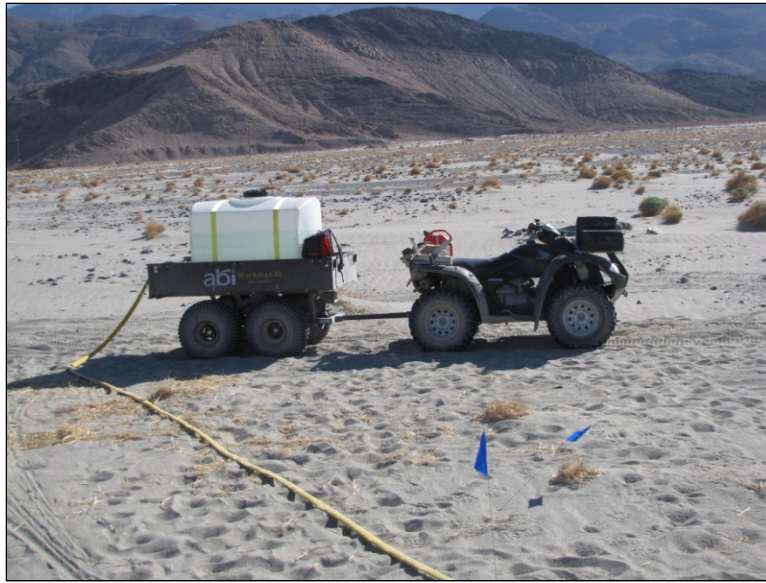
**Photo 9.** Water tank and fire hose system used to provide water to the plants on the test site.

A portable watering system is used to provide water to the plants on the test site. The system consists of a 250 gallon plastic tank and small pump mounted on an ATV trailer. The water is transported from the tank to the planted bales through a 1-inch fire hose (Photo 9). The water tank is filled with water at the District's Keeler field office/yard. Fertilizer was applied once to the plants on the test site. The application was conducted on July 3, 2013 and consisted of approximately 1 teaspoon of slow release fertilizer pellets (Osmocote Smart-release Plant Food 14-14-14) added to each watering tube.

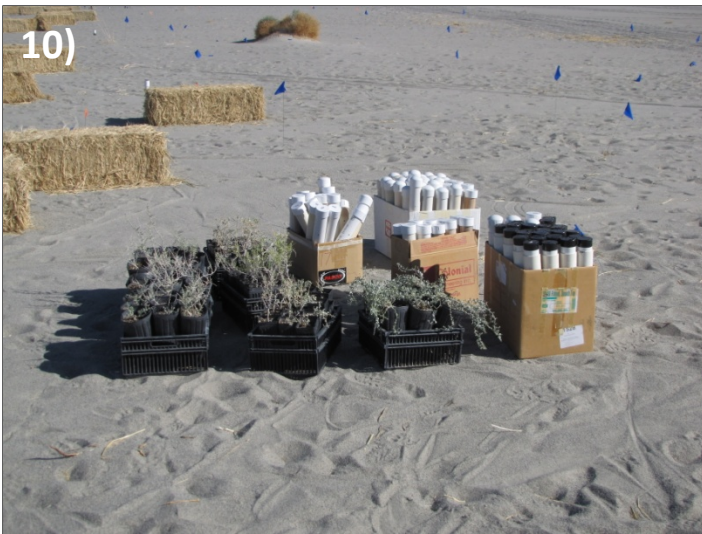
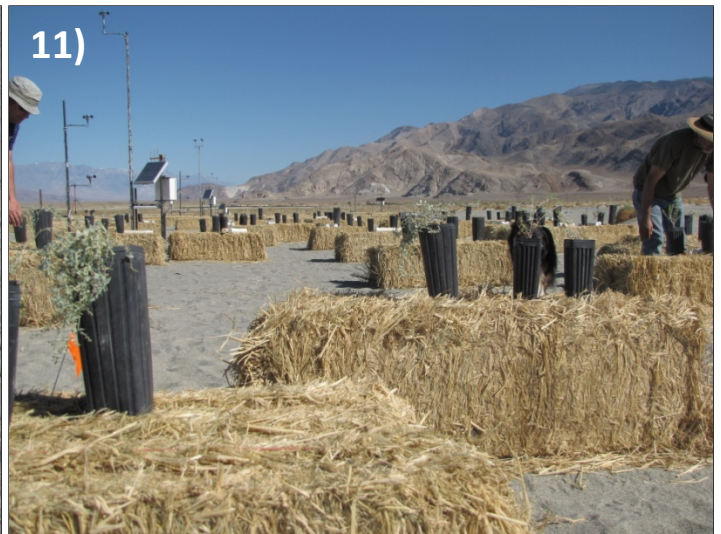
**Photos 10 and 11.** Photos showing the long leggy stems of the ATPA on May 30, 2013. Photo 10 (left) shows the contrast in plant structure between the ATPA (in the tray near the cardboard box) and the rest of the plants. Photo 11 (right) shows a close up of an ATPA in its pot prior to planting. Notice the long leggy stems draped over the edge of the pot.

The cause for the high death rate for the ATPA is uncertain but is thought to be related to the long flexible (“leggy”) plant stems and poor root development. Instead of having a stiff upright stem structure, the ATPA plants placed on the test site in May 30, 2013 were short in height and had long leggy stems (Photos 10 and 11). Observations made during plant monitoring events note that the ATPA stems were buried and burned by the hot sand moving within the project. District staff uncovered the affected plants on several occasions from the sand that covered them but generally the damage was already done. Another contributing factor to the high mortality of the ATPA is thought to be the root development structure. While being planted on the test site, the soil of many of the ATPA “fell apart” when the plant was removed from the pot for placement into the prepared trench. This did not occur with the other plant species and is thought to have occurred due to the root distribution of the ATPA. Instead of having roots distributed throughout the soil column in the pot, roots were concentrated at the top near the surface and at the base of the pot with very few roots in-between creating poor soil-root integrity.

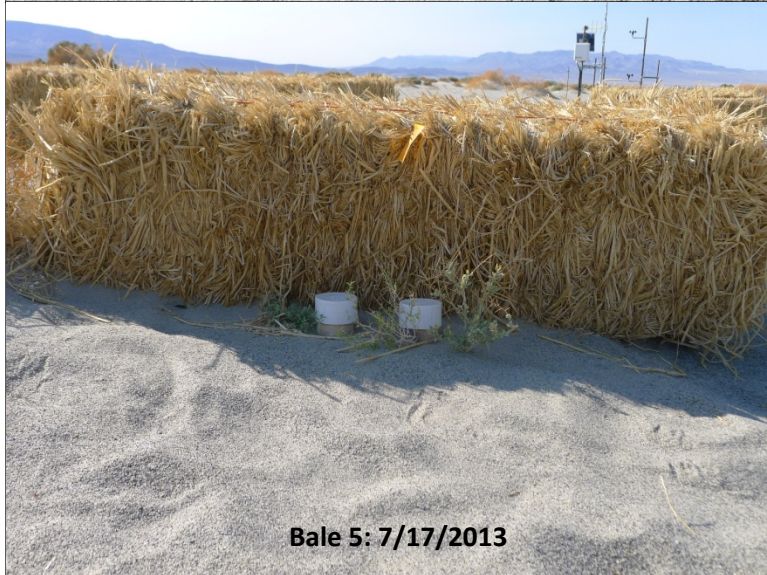
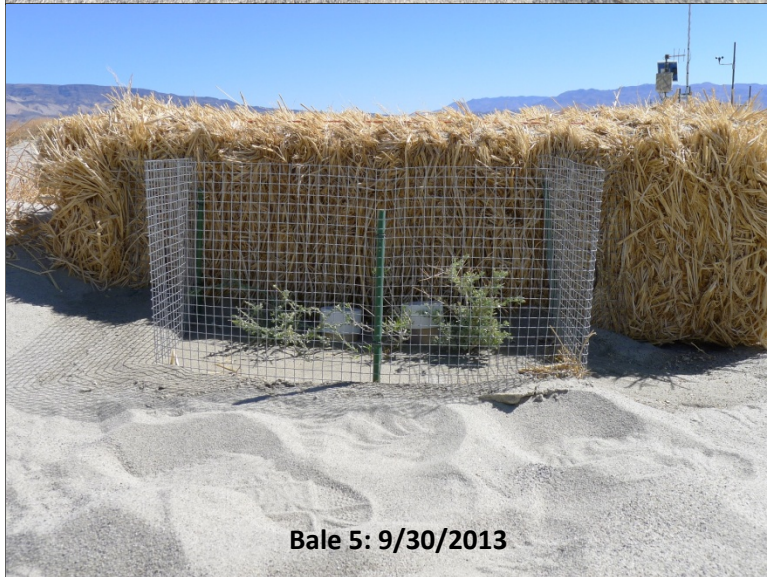
**Photo 12:** Monitoring photos taken of the plants at Bale number 5 showing the plants from three dates from May to September 2013. The plants are numbered 1, 2, and 3 sequentially from left to right. On September 30, 2013 (bottom photo) the vigor rankings were Plant 1 (ATPO) = Excellent, Plant 2 (SAVE) = Good, and Plant 3 (ATCO) = Good

**A) May 30, 2013:** date of planting

**B) July 17, 2013:**

**C) September 30, 2013:** Notice the wire protective structure placed around the plants to prevent browsing impacts on the SAVE.

To illustrate the change over the first four months of the project, photo sequences of the plants at three different bales are presented in Photos 12-14. The photos were taken on three dates; at the time of planting (5/30/2013), mid-summer (7/17/2013), and at the end of September (9/30/13). The photos taken at bale numbers 5, 8 and 47 (see Photos 12- 14) illustrate the overall growth and Good to Excellent vigor rating of the ATPO and ATCO plants over the course of the summer. An example of one of the wire protective structures installed to protect the SAVE and SUMO plants is visible in Photo 12C.

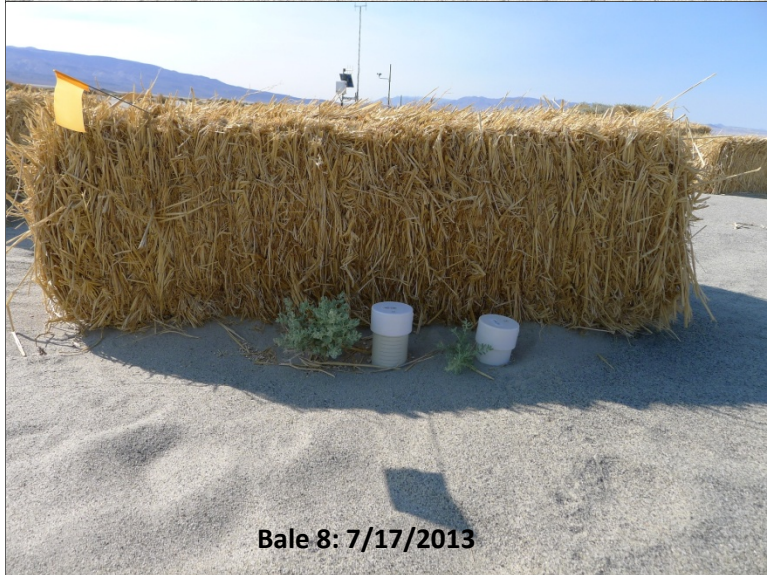
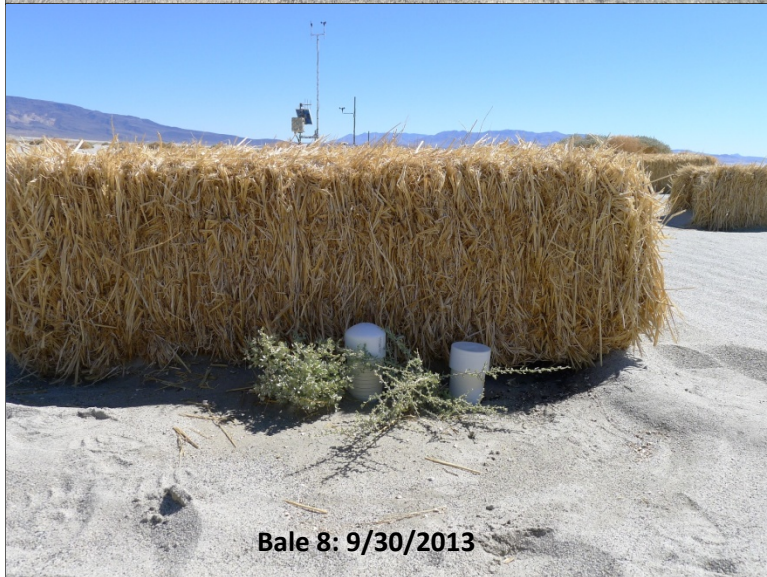
**Photo 13:** Monitoring photos taken of the plants at Bale number 8 showing the plants from three dates from May to September 2013. The plants are numbered 1, 2, and 3 sequentially from left to right. On September 30, 2013 (bottom photo) the vigor rankings were Plant 1 (ATCO) = Excellent, Plant 2 (ATPO) = Excellent, and Plant 3 (ATPA) = Dead

**A) May 30, 2013:** Notice the leggy structure of the ATPA on the right.

**B) July 17, 2013**

**C) September 30, 2013:** Notice the Excellent vigor of the ATCO and ATPO and that the ATPA is now Dead.

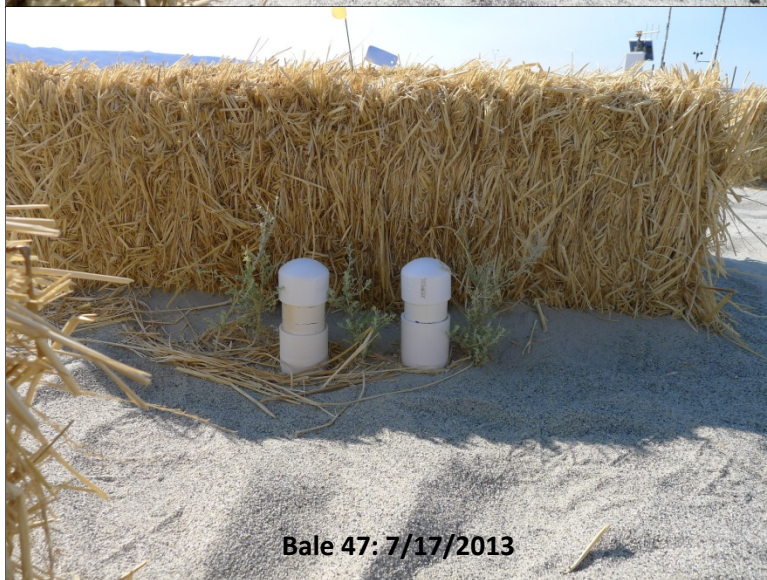
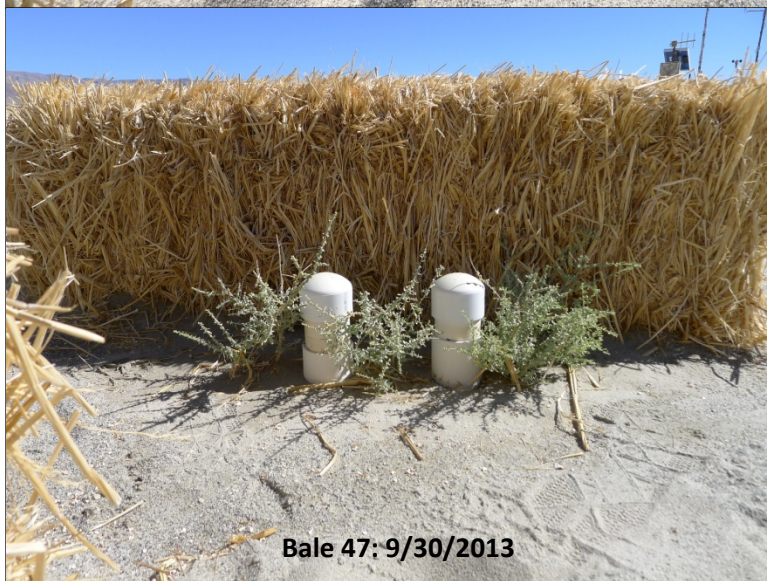
**Photo 14:** Monitoring photos taken of the plants at Bale number 47 showing the plants from three dates from May to September 2013. The plants are numbered 1, 2, and 3 sequentially from left to right. On September 30, 2013 (bottom photo) the vigor rankings for all three ATPO plants was Excellent.

**A) May 30, 2013**

**B) July 17, 2013**

**C) September 30, 2013:** Notice the continued growth of the ATPO from May to September.
